Hertfordshire County Council Flood Investigation Report Knebworth, Hertfordshire

Hertfordshire County Council Knebworth Flood Investigation Report

Thursday 8 January 2015
Revision 4 - Final

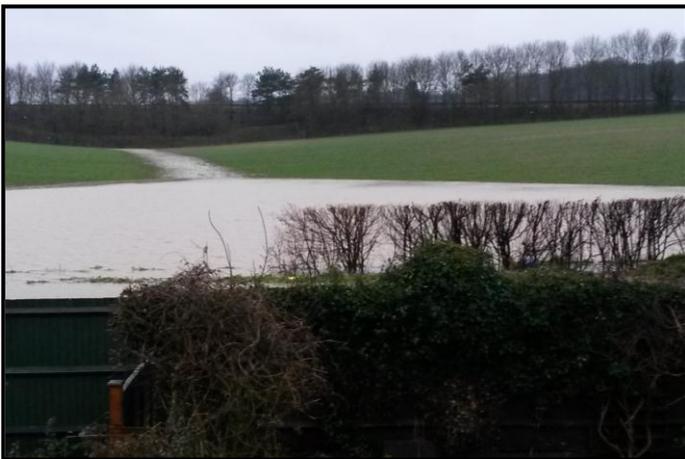
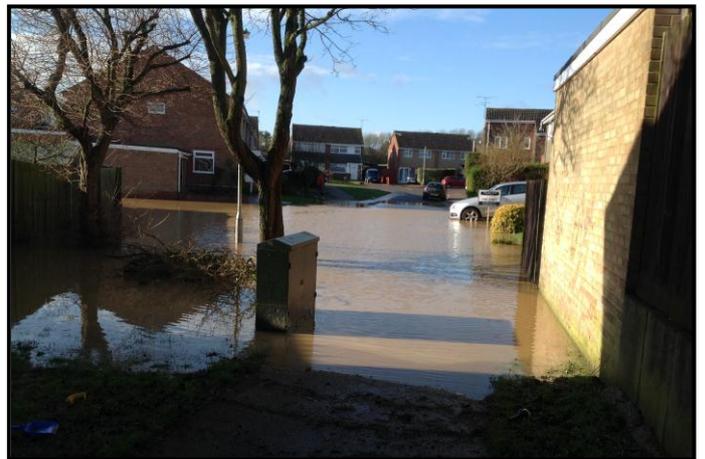
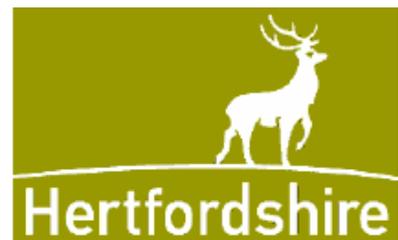
Photos courtesy of local residents

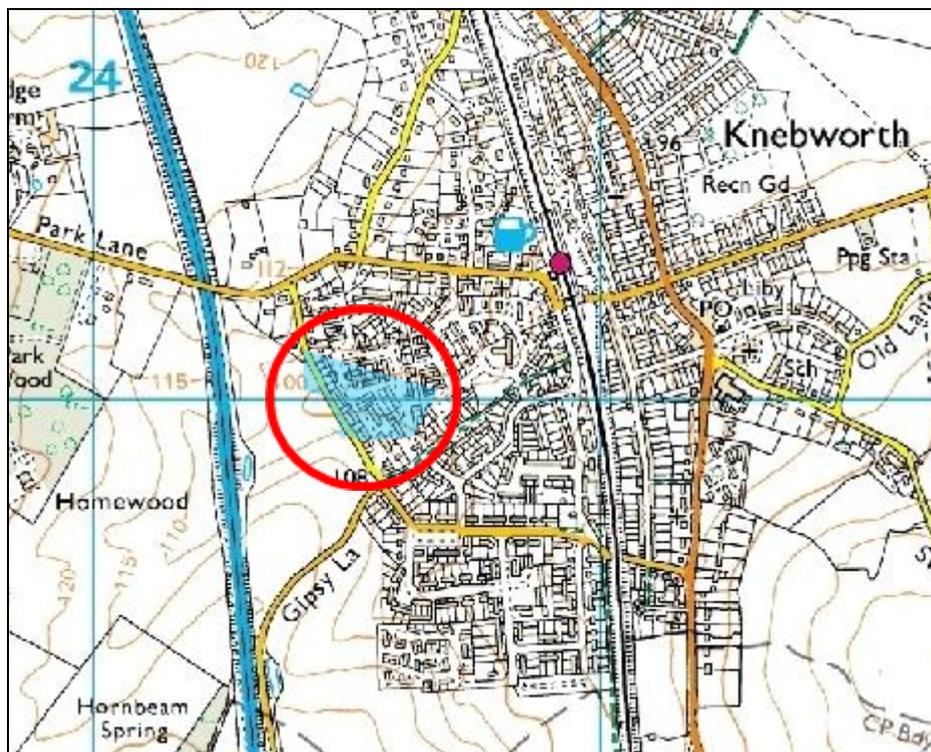
Figure 1.2 Area affected by flooding in Knebworth

The village of Knebworth is situated to the south of Stevenage, in the north of Hertfordshire. This is illustrated in Figure 1.1. The site affected by flooding is located in the west of Knebworth, to the east of Gypsy Lane, as shown in Figure 1.2.

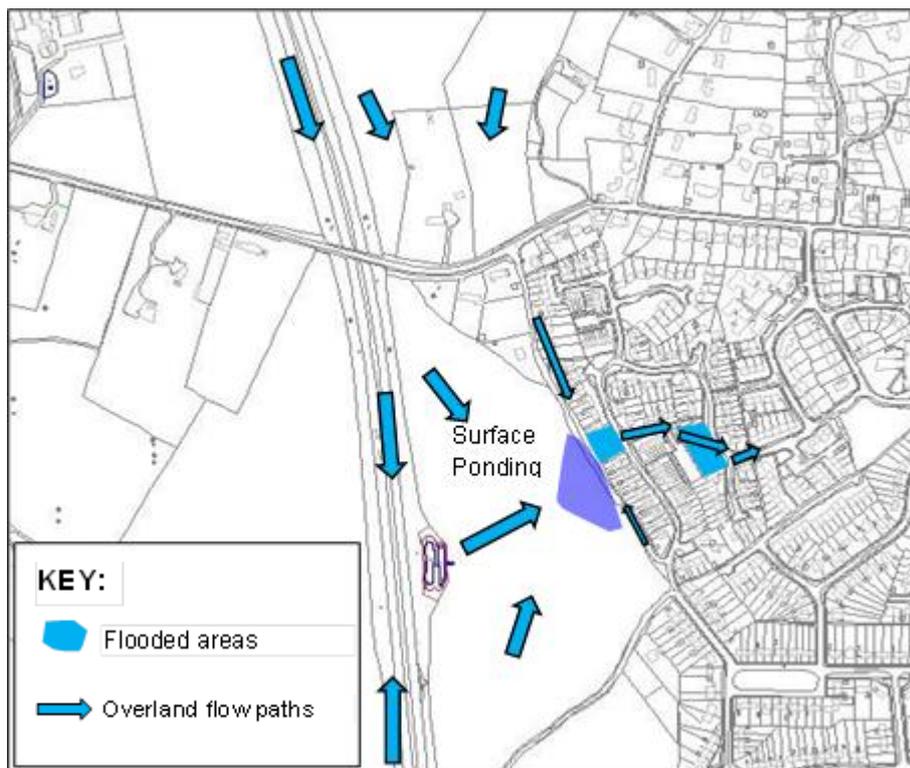
Figure 3.1 Overland flow paths

In Knebworth in the early hours of the morning on 7 February 2014, heavy rainfall fell on saturated ground, causing surface water runoff from farmland onto an adjacent road, Gypsy Lane. The water flooded the lane and subsequently flowed into rear gardens in Orchard Way before entering these properties through rear doors. Water also found its way around the sides of Orchard Way properties, into front gardens and the road, flowing down the natural slope towards the entrance to garages and the rear gardens of Broom Grove properties.

Properties in Broom Grove were flooded as the water continued through their rear gardens, entering via rear doors. Water flowed out of front doors and into front gardens and the road, eventually ponding in the road at the entrance of the walkway to Gibbons Way.

A total of 20 properties were flooded; 18 internally. Figure 3.1 shows the flow route the water took.

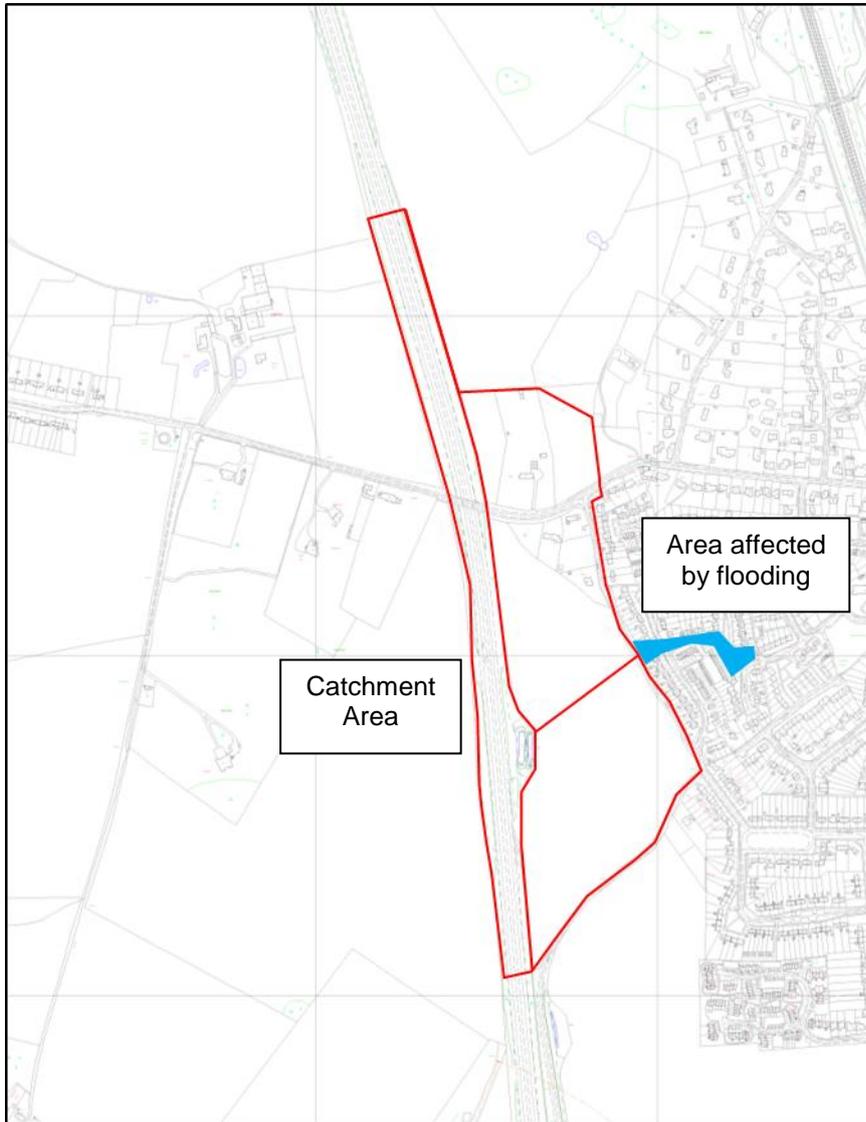
Figure 3.2 Catchment boundary

The catchment that drains to the area which flooded measures approximately 29 ha. This is shown in Figure 3.2. The catchment is relatively steep, sloping eastwards from a high point to the west at approximately 122m elevation, to the lowest point in Broom Grove in the east at an elevation of approximately 101m.

There is arable farmland to the west of Gypsy Lane, with the A1(M) forming the western catchment boundary.

There is also an attenuation storage pond for the A1(M), which is designed to slow the passage of surface water runoff from the motorway. The runoff is stored during peak flow and released slowly at a controlled rate to allow infiltration into the ground after peak flow has passed.

Arable land and part of Park lane form the northern part of the catchment.

Surface water runoff from the whole catchment is funnelled into the field adjacent to Gypsy Lane, opposite the rear gardens of Orchard Way. Any overspill from the A1(M) attenuation storage pond would also flow to this point.
